## Port of Esperance Survey of Lead and Nickel in Marine Sediments

Level (Stage) 2 – Bioavailability Investigation Report

January 2008

*Report No. 606\_001/1*

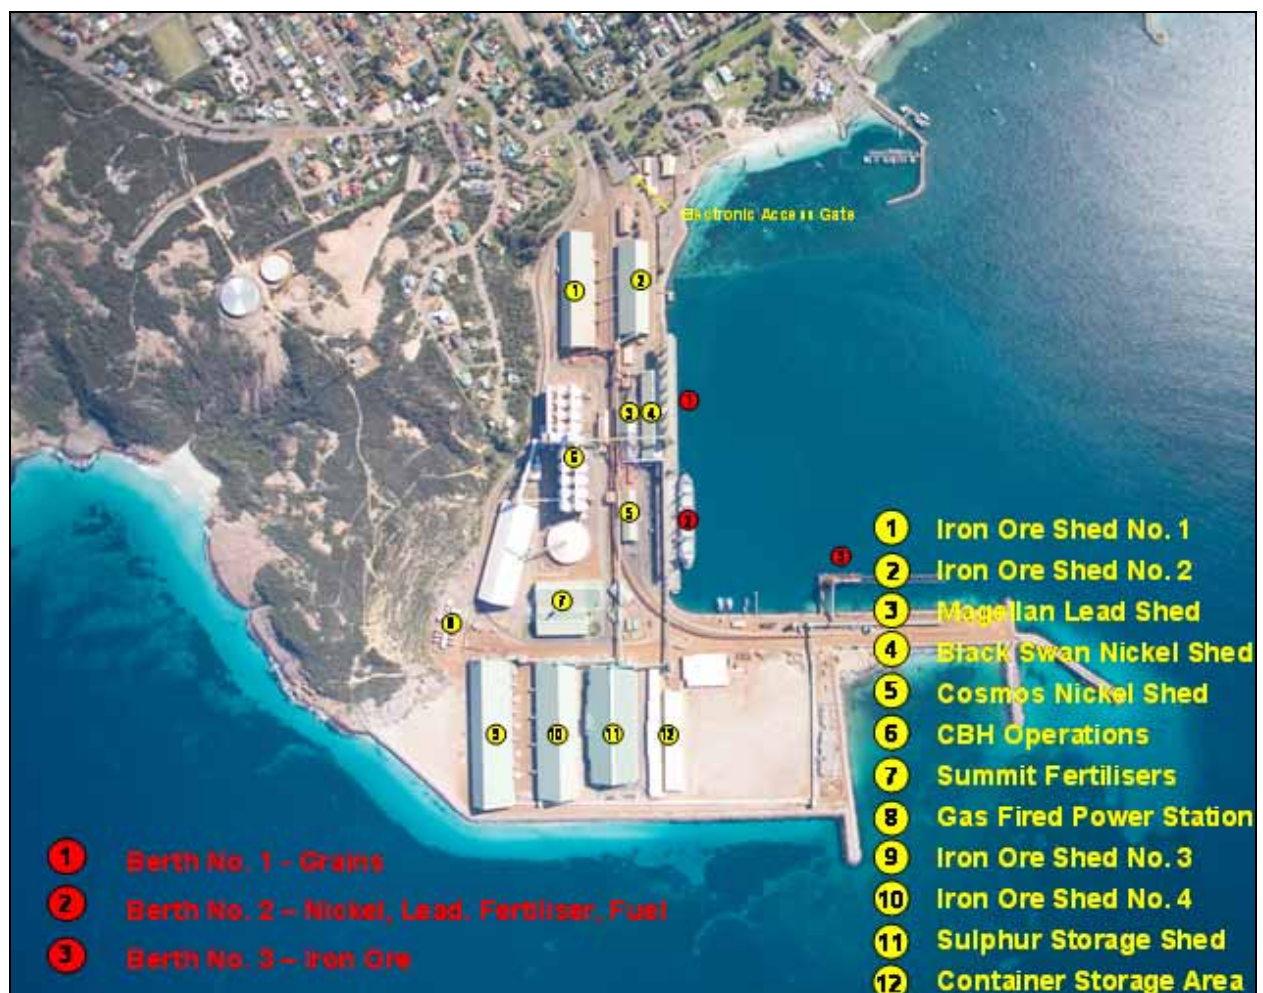
Figure 1.1 Esperance Port berths (red dots) and facilities (yellow dots)

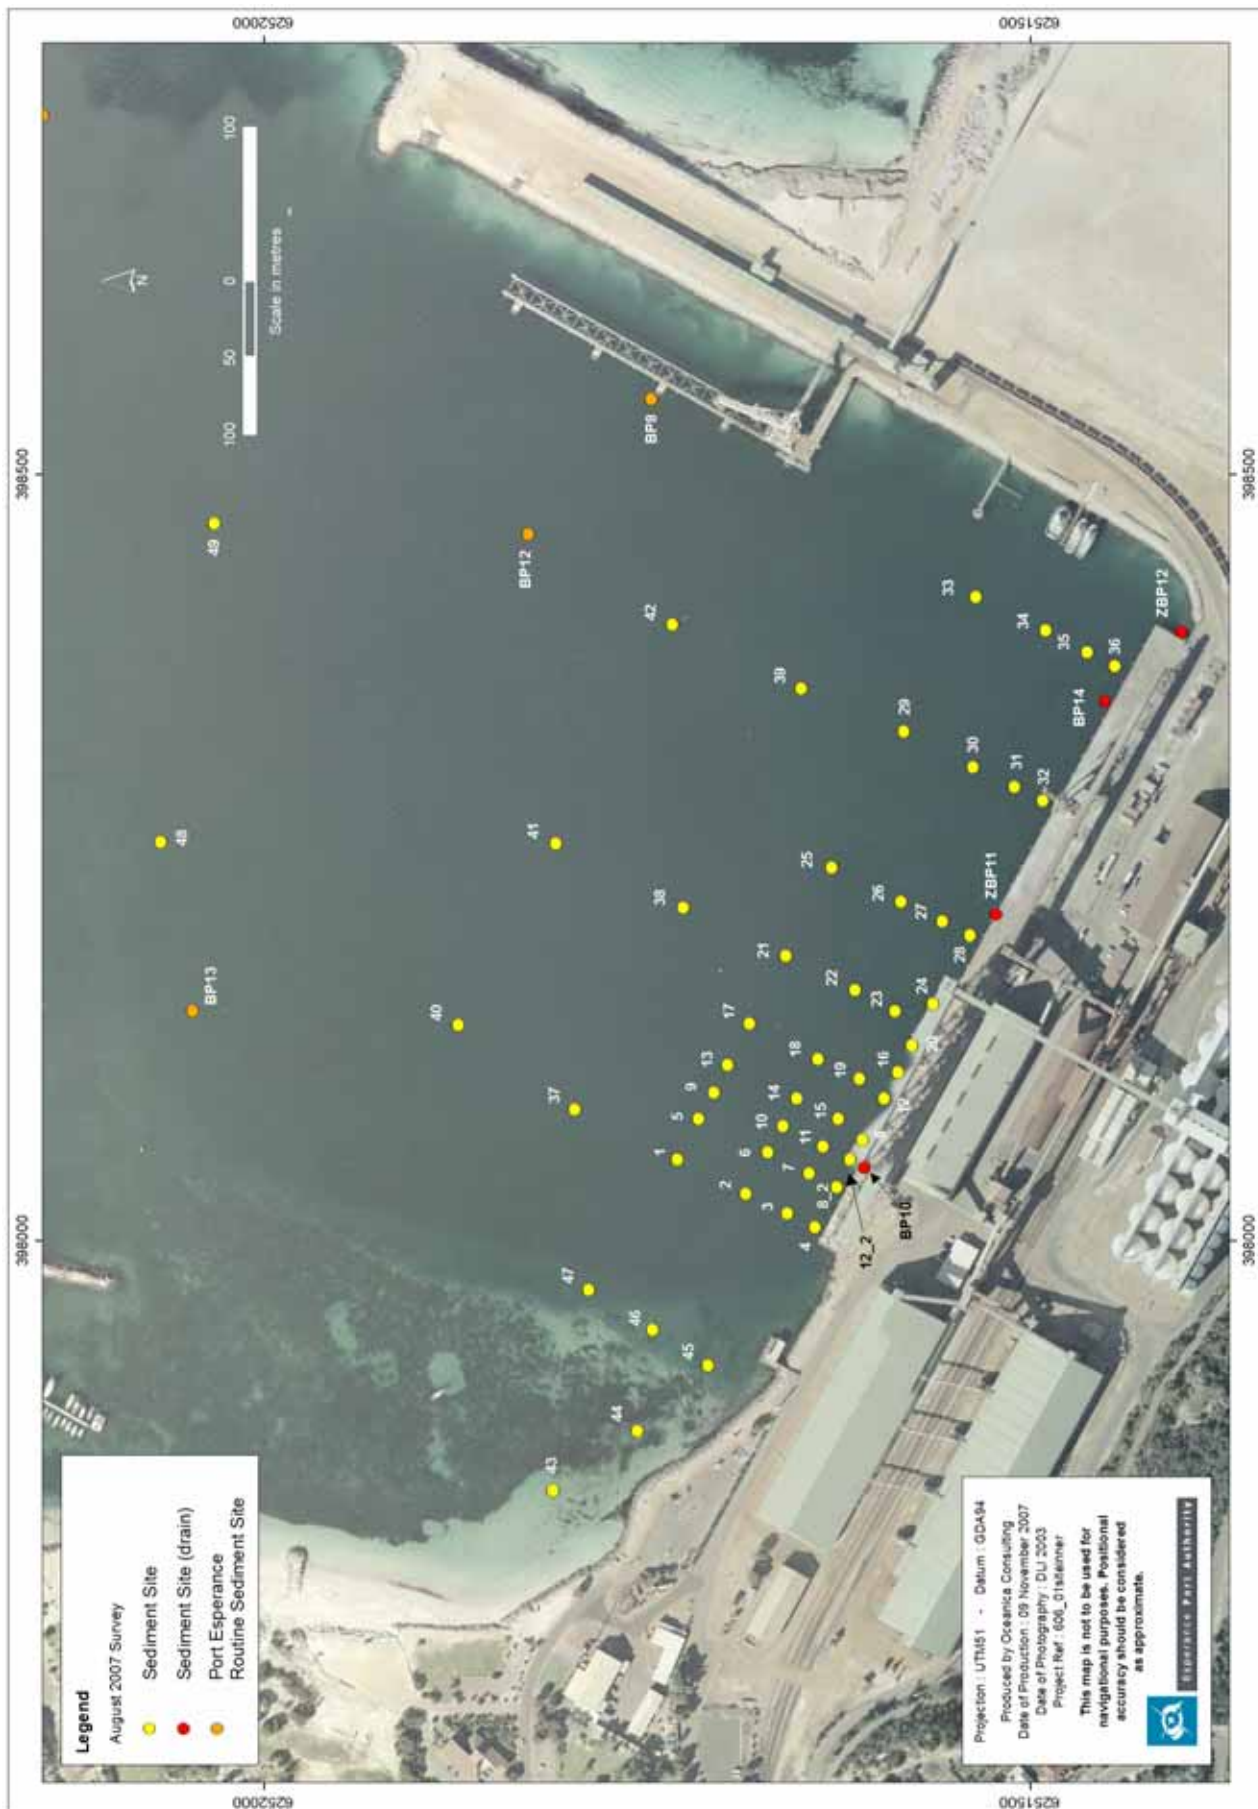
Figure 2.1 Detailed view of location of sediment sampling sites in Esperance Port (August 2007)

The location of the sites sampled in the Stage 1 analysis is given in Figure 2.1. The site locations sampled were largely as described in the SAP, with some slight modifications. Due to initial lack of information on exactly where the discharge pipe was located, the location of some sites shown in Figure 2.1 of the SAP was shifted slightly (~15 m) to better cover the area adjacent to the pipe: sites 8 and 12 had already been sampled before the correct location of the discharge pipe was confirmed, and so re-sampling was required (shown as 8\_2 and 12\_2 in Figure 2.1). In addition, several other potential point source discharges were identified along Berth 1 and Berth 2, so some sites were re-aligned to better track contamination trends adjacent to these locations.

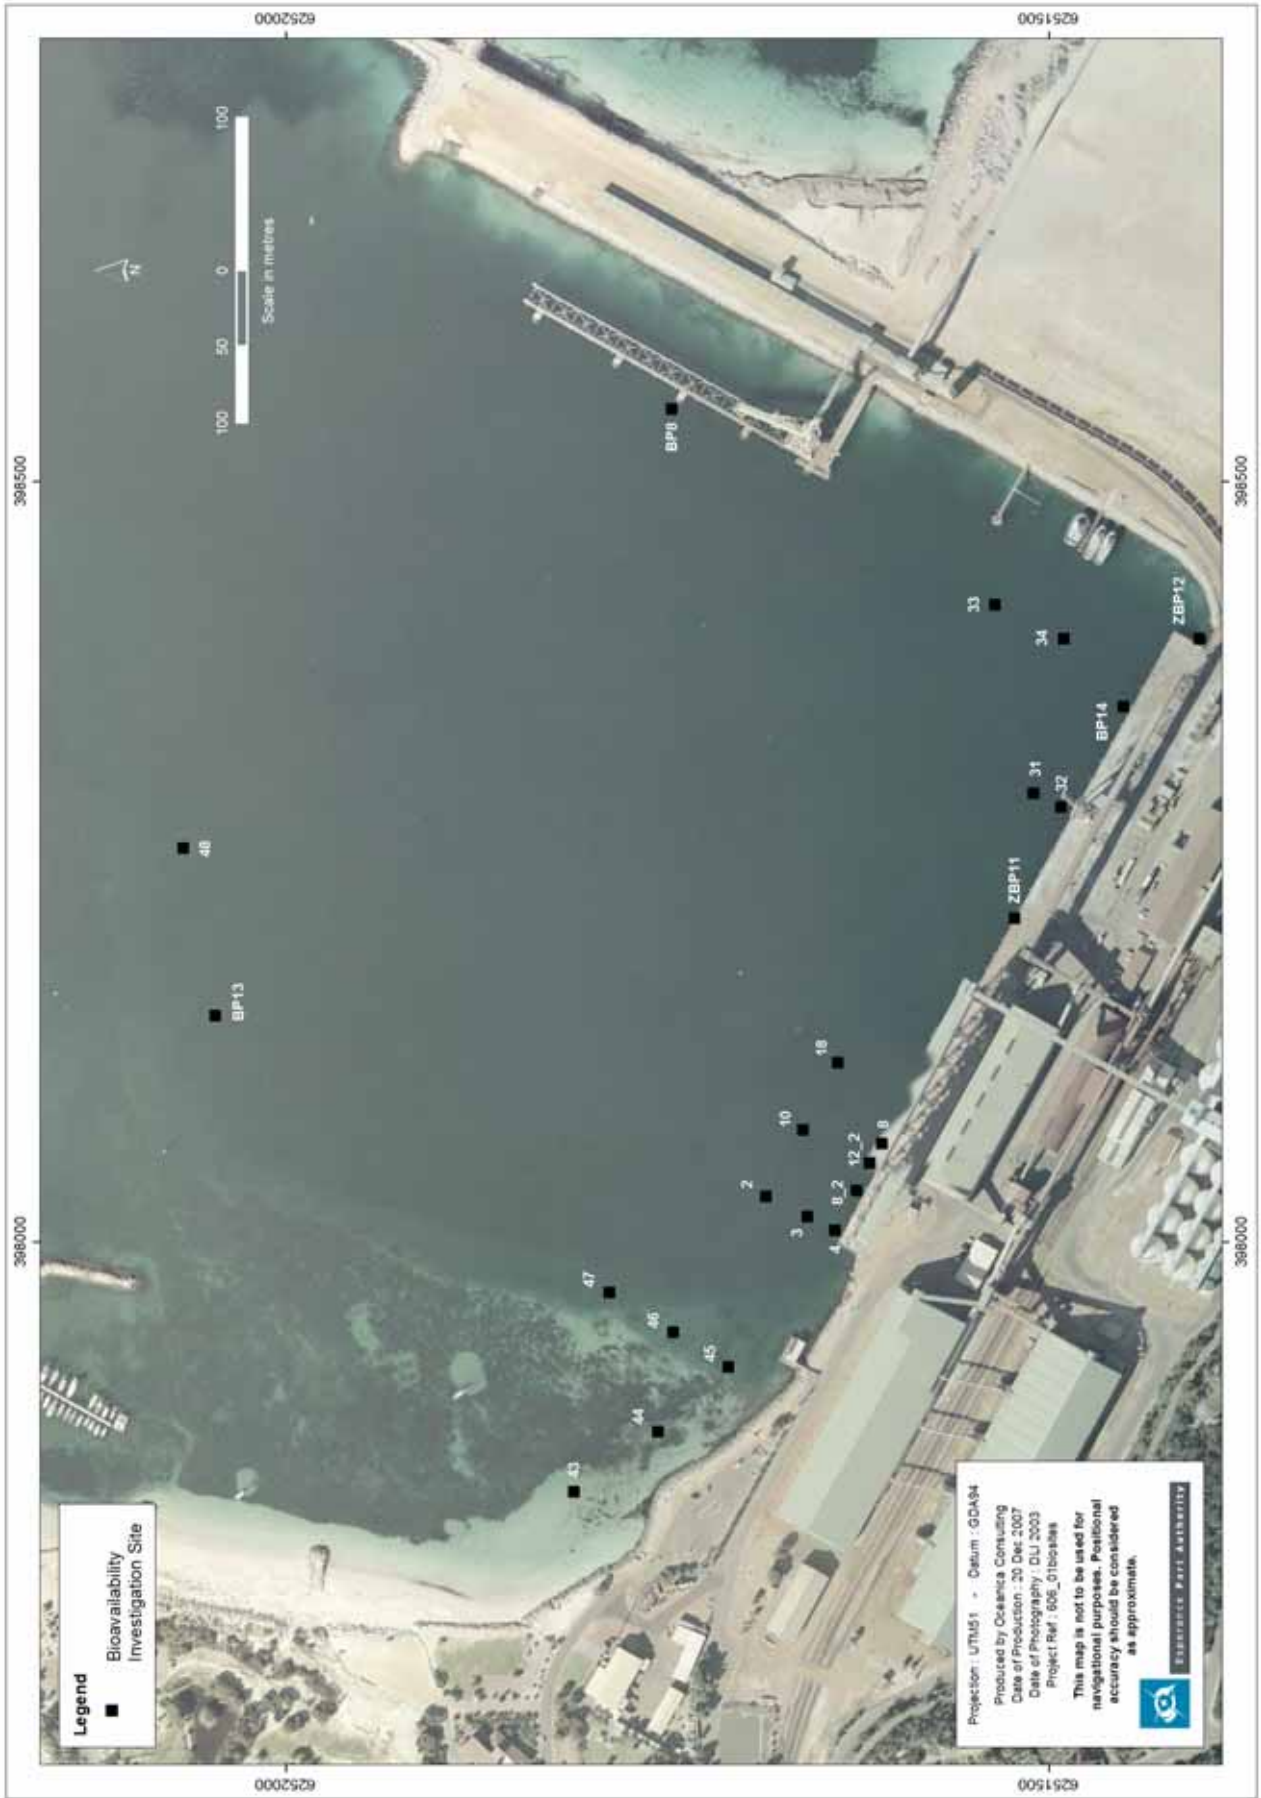
**Figure 2.3** Location of samples for dilute acid extraction of bioavailable lead and nickel

The areas were classified based on results presented in Oceanica 2007b and shown in Figure 3.3 and Figure 3.5 of this report. After the classification of the areas a dilute acid extraction was performed on 50% of the samples obtained from the contaminated areas, with those samples exhibiting total metal concentrations closest to the median selected for further analysis. The Marine and Freshwater Research Laboratory (MAFRL) undertook analysis of bioavailable nickel and lead from each of the sites identified as requiring either lead or nickel bioavailability investigation. As a result several samples were analysed for both lead and nickel, when the total metal concentration of one of these metals had been below the ISQG-low). Testing for bioavailable lead and nickel was undertaken on the following samples (see Figure 2.3):

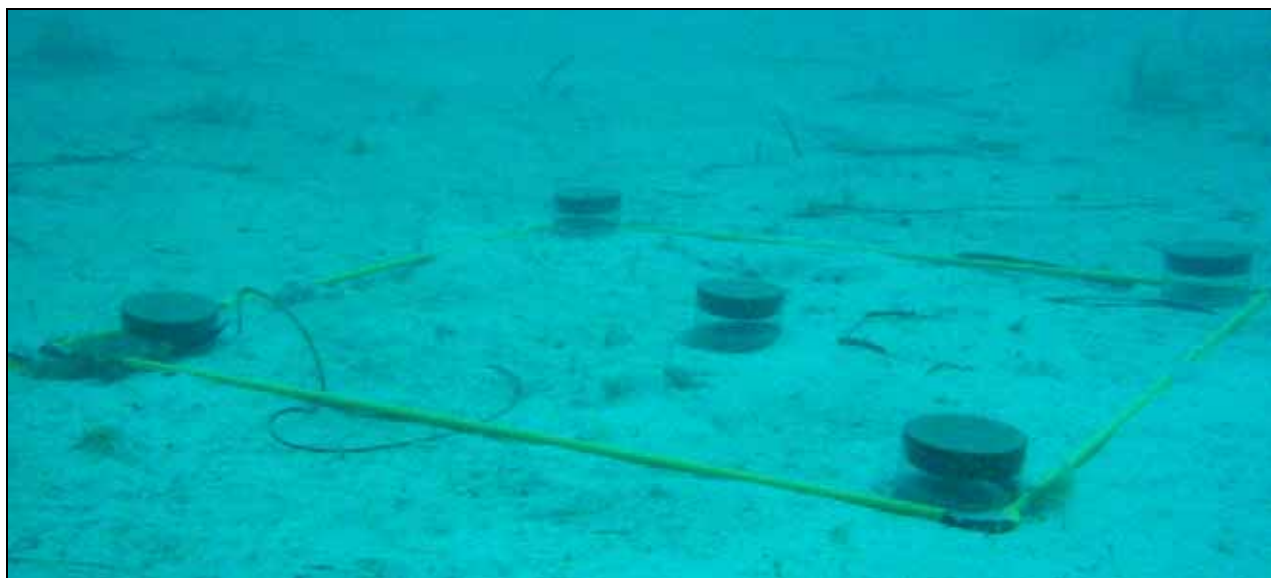
**Figure 2.4** Five cores within 1 m<sup>2</sup> quadrat to make one composite sample (Esperance Port, August 2007, Oceanica 2007)

Three replicate samples were obtained from each site within 5 m of each other. Each replicate consisted of a composite of the top 2 cm of five cores taken from each corner and the centre of a 1 m<sup>2</sup> quadrat, according to the methods in EPA (2005b) (Figure 2.4). The composited material was thoroughly mixed before sub-sampling.

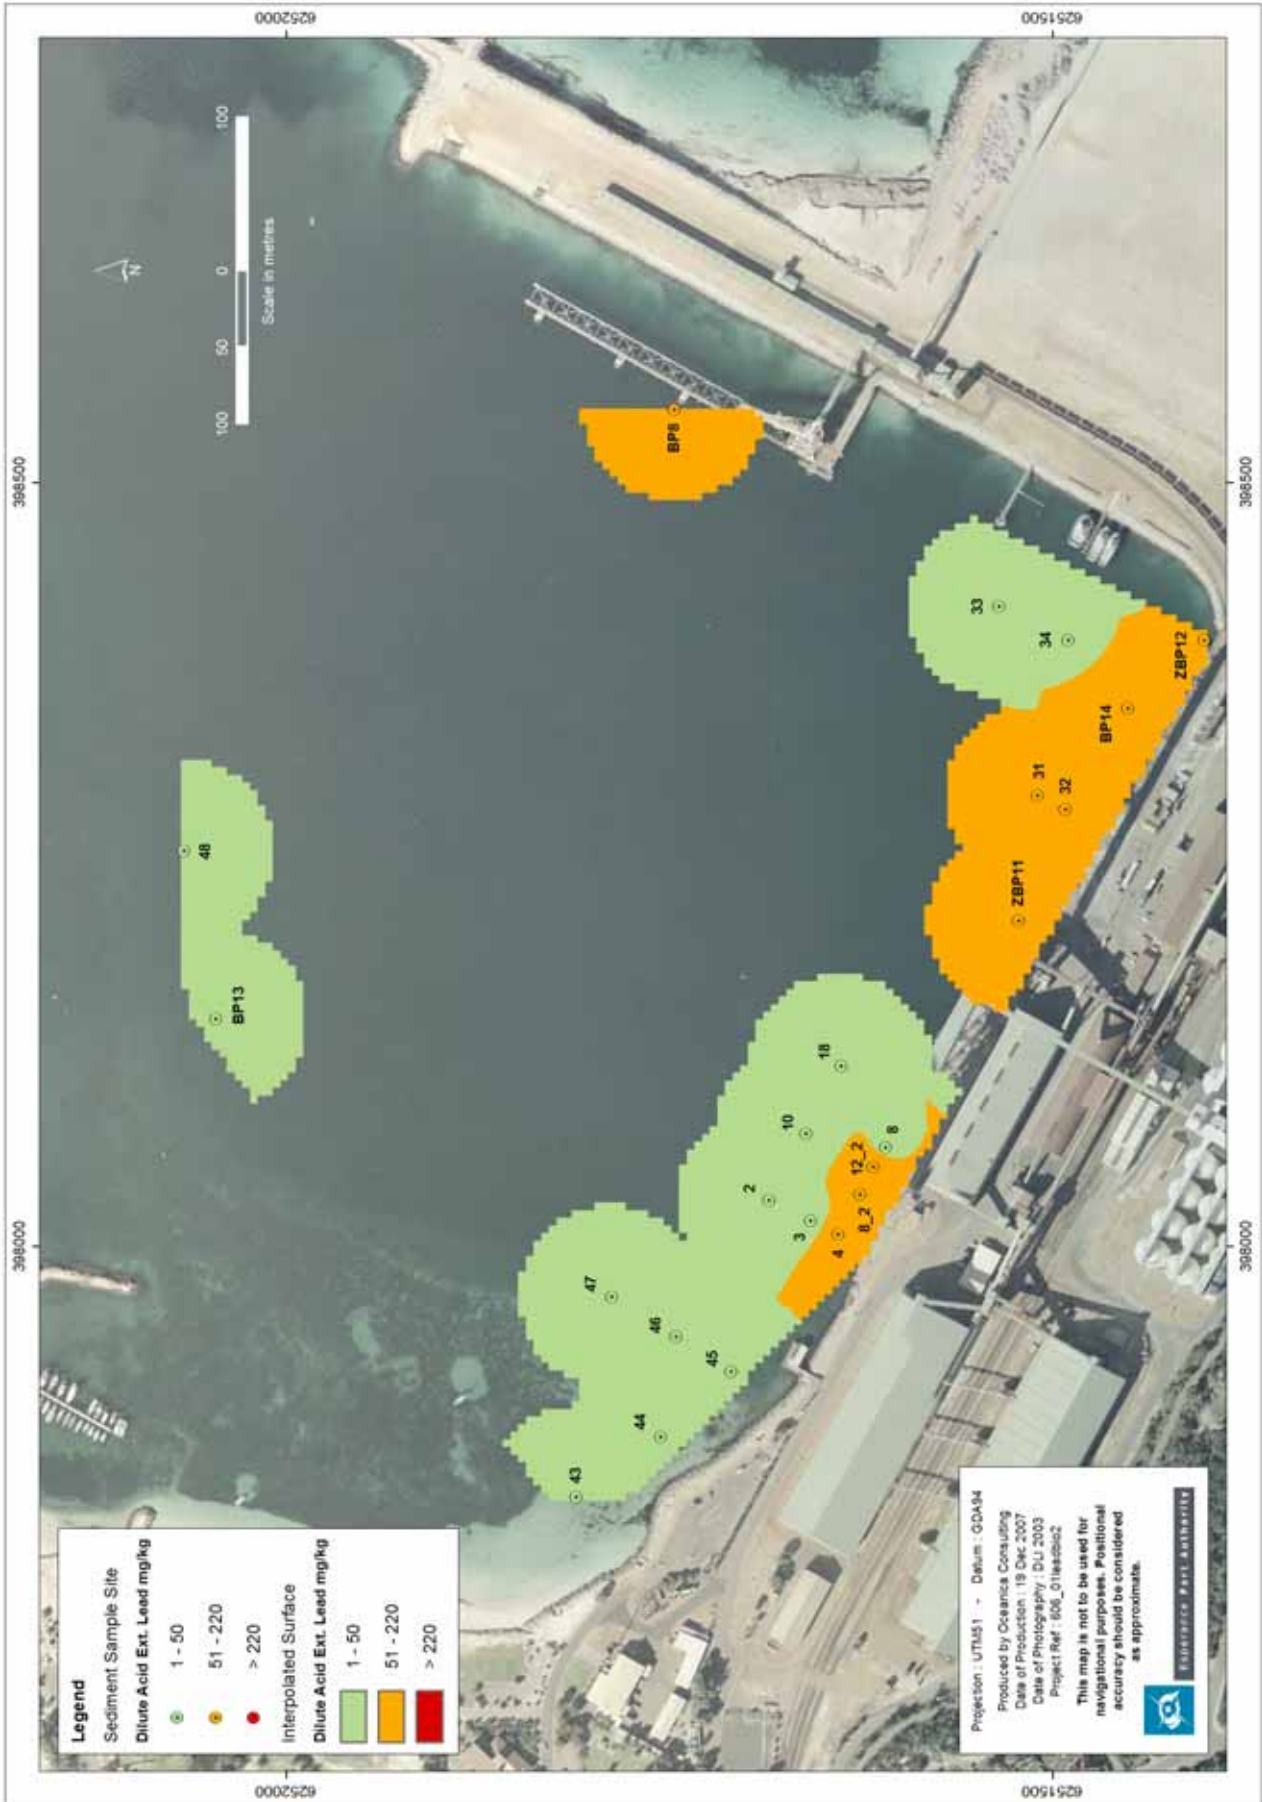
**Figure 3.2 Detailed view of spatial pattern of lead contamination (dilute acid extraction) in the surficial sediments of Esperance Port**

Note: Central area unshaded because no dilute acid extractions done on these sediments (ISQG-Low not exceeded in strong acid extractions, see Figure 3.3)

Figure 3.2 and Figure 3.3 show the spatial extent of lead contamination for dilute and strong acid extraction, respectively. Figure 3.4 and Figure 3.5 shows the spatial extent of nickel contamination for dilute and strong acid extraction, respectively. In accordance with the SAP for this study (Oceanica 2007a), areas have been stratified based upon their contamination status: 'uncontaminated' (median lead and nickel concentrations equal to background, in this case taken as below laboratory reporting limit), 'slightly contaminated-low risk' (median lead and nickel concentrations below ISQG-Low values and no site exceeding ISQG-High values) and 'contaminated' (median value from a site exceeding the ISQG-Low, and/or an individual sample exceeding the ISQG-High).

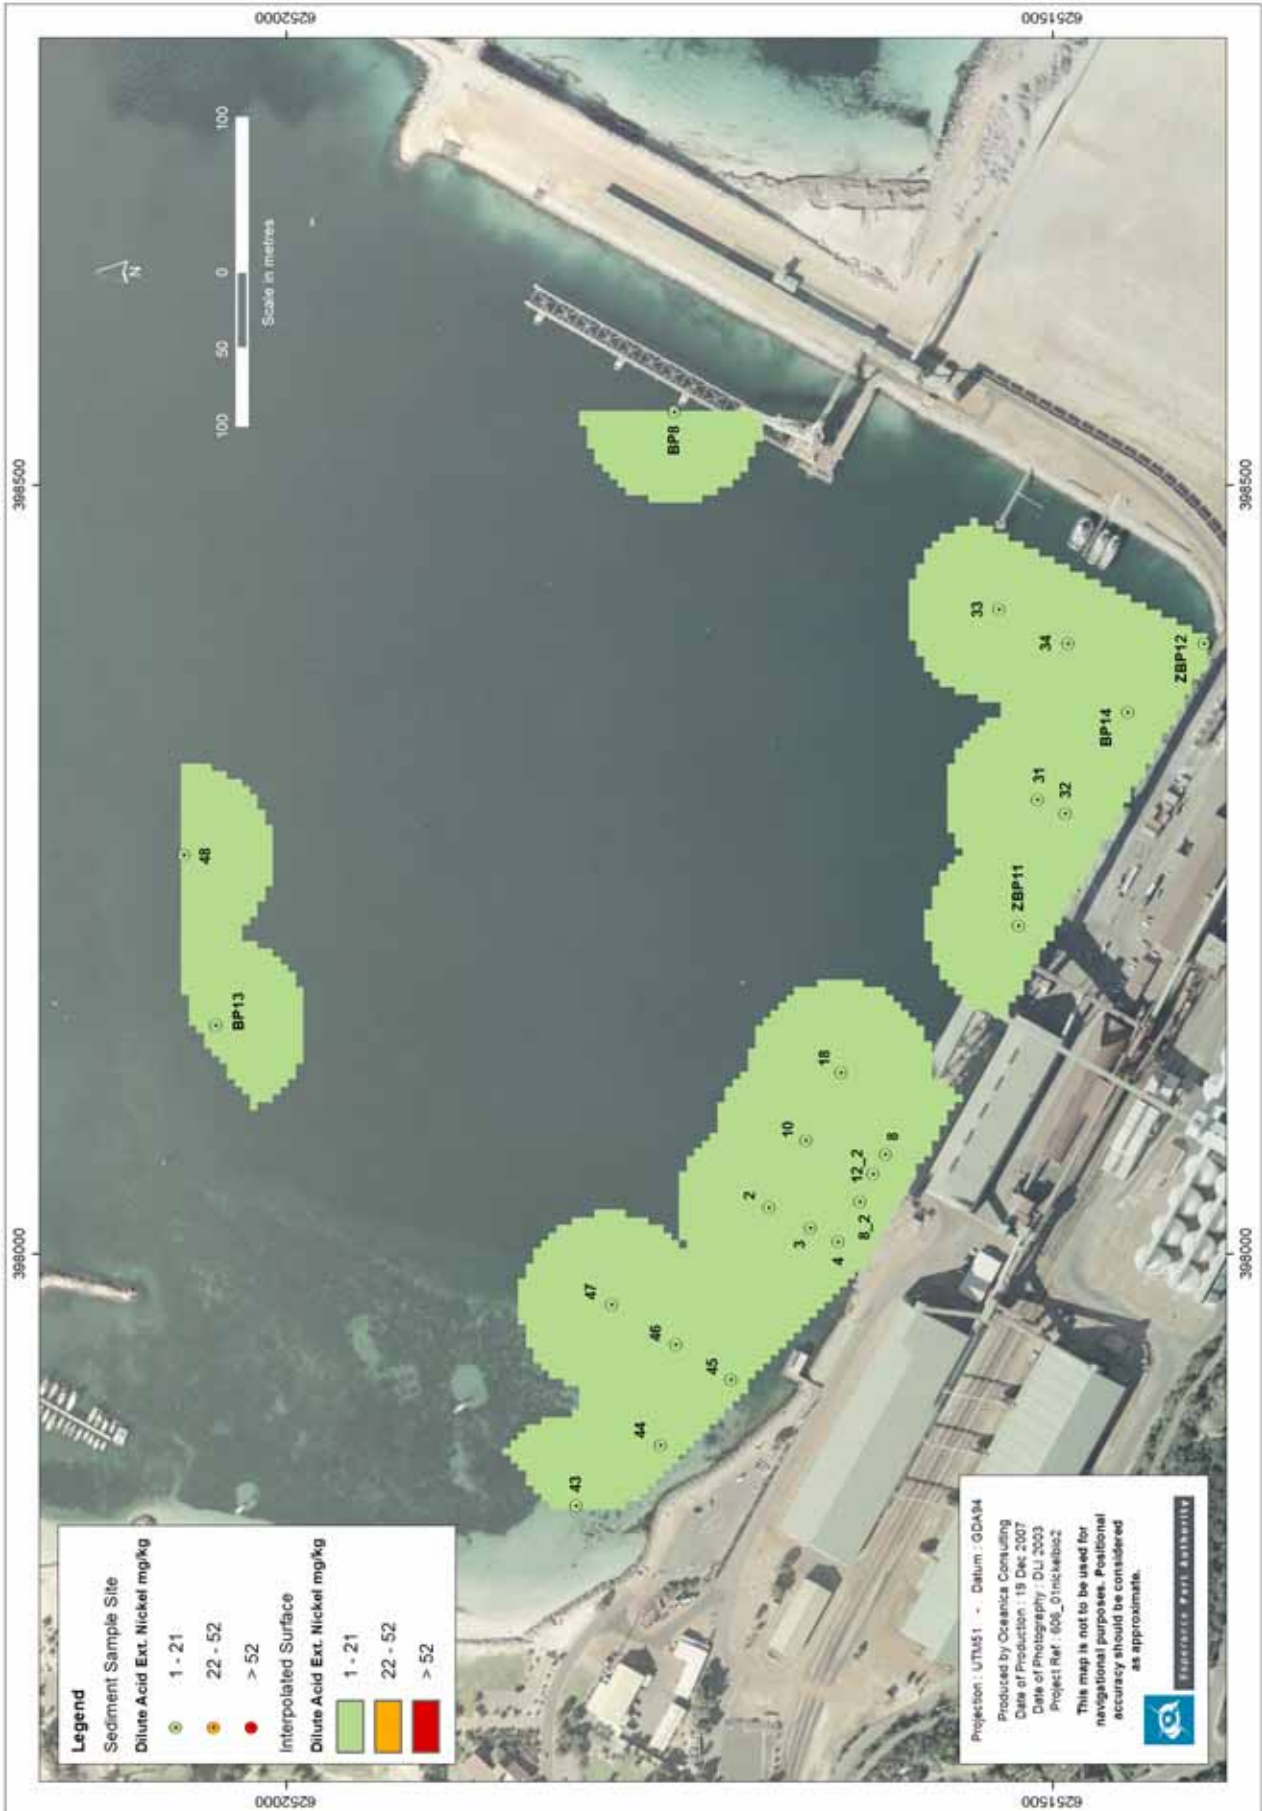
**Figure 3.4 Detailed view of spatial pattern of nickel contamination (dilute acid extraction) in the surficial sediments of Esperance Port**

Note: Central area unshaded because no dilute acid extractions done on these sediments (ISQG-Low not exceeded in strong acid extractions, see Figure 3.5)
